Manhole Inspection Summary

Manhole # S41I__015MH

Location Address: **205 s exeter st**

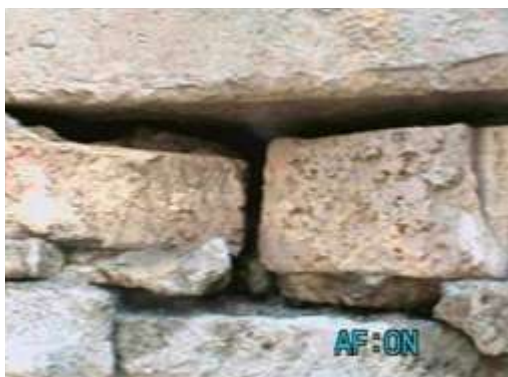
Defect 2

Condition: ☐ Sound ☒ **Cracked** ☐ Root Intrusion ☒ **Loose Brick** ☐ Deteriorated

chimney cracked with loose brick

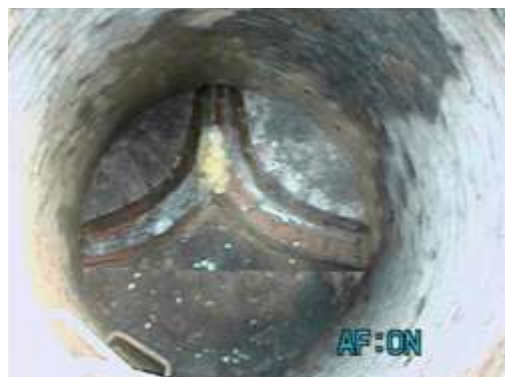
Defect 4

Infiltration: ☐ None ☐ Joint ☐ Cracks ☐ Mortar ☐ Roots ☒ **Wall**

infiltration coming from barrel wall

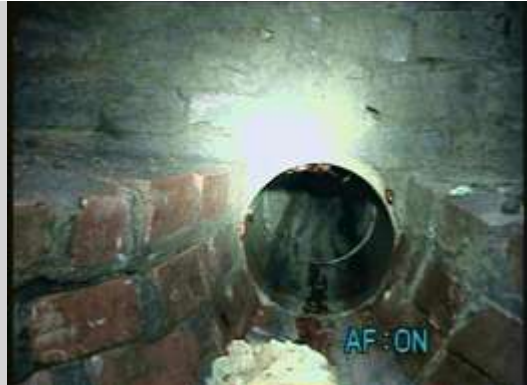
12 O'Clock Outflow

8 in. Circular Gravity Sewer
Pipe Out @ 12 O'Clock

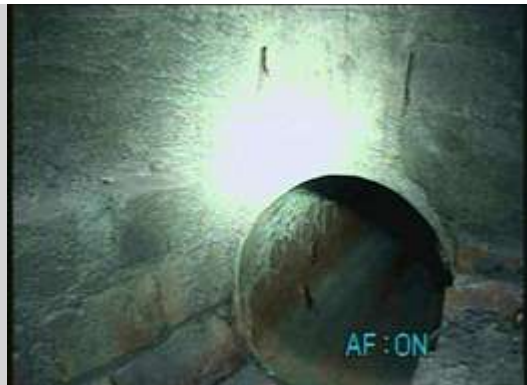
3 O'Clock Inflow

8 in. Circular Gravity Sewer
Pipe In @ 3 O'Clock

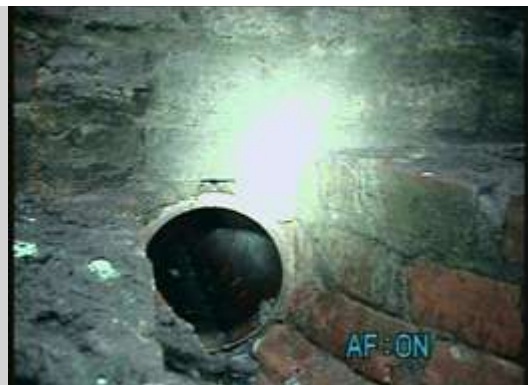
9 O'Clock Inflow

8 in. Circular Gravity Sewer
Pipe In @ 9 O'Clock
